Utah Geological Survey

Project: Reconnaissance of the April 9, 2006, 1650 East landslide, South Weber, Utah		
By: Richard E. Giraud, P.G. and Greg N. McDonald, P.G.	Date: 07-26-06	County: Davis
USGS Quadrangles: Ogden (1345)	Section/Township/Range: SW $\frac{1}{4}$ NE $\frac{1}{4}$ section 34, T. 5 N., R. 1 W., SLBLM	
Requested by: Ron Chandler, South Weber City Manager		Job number: 06-10

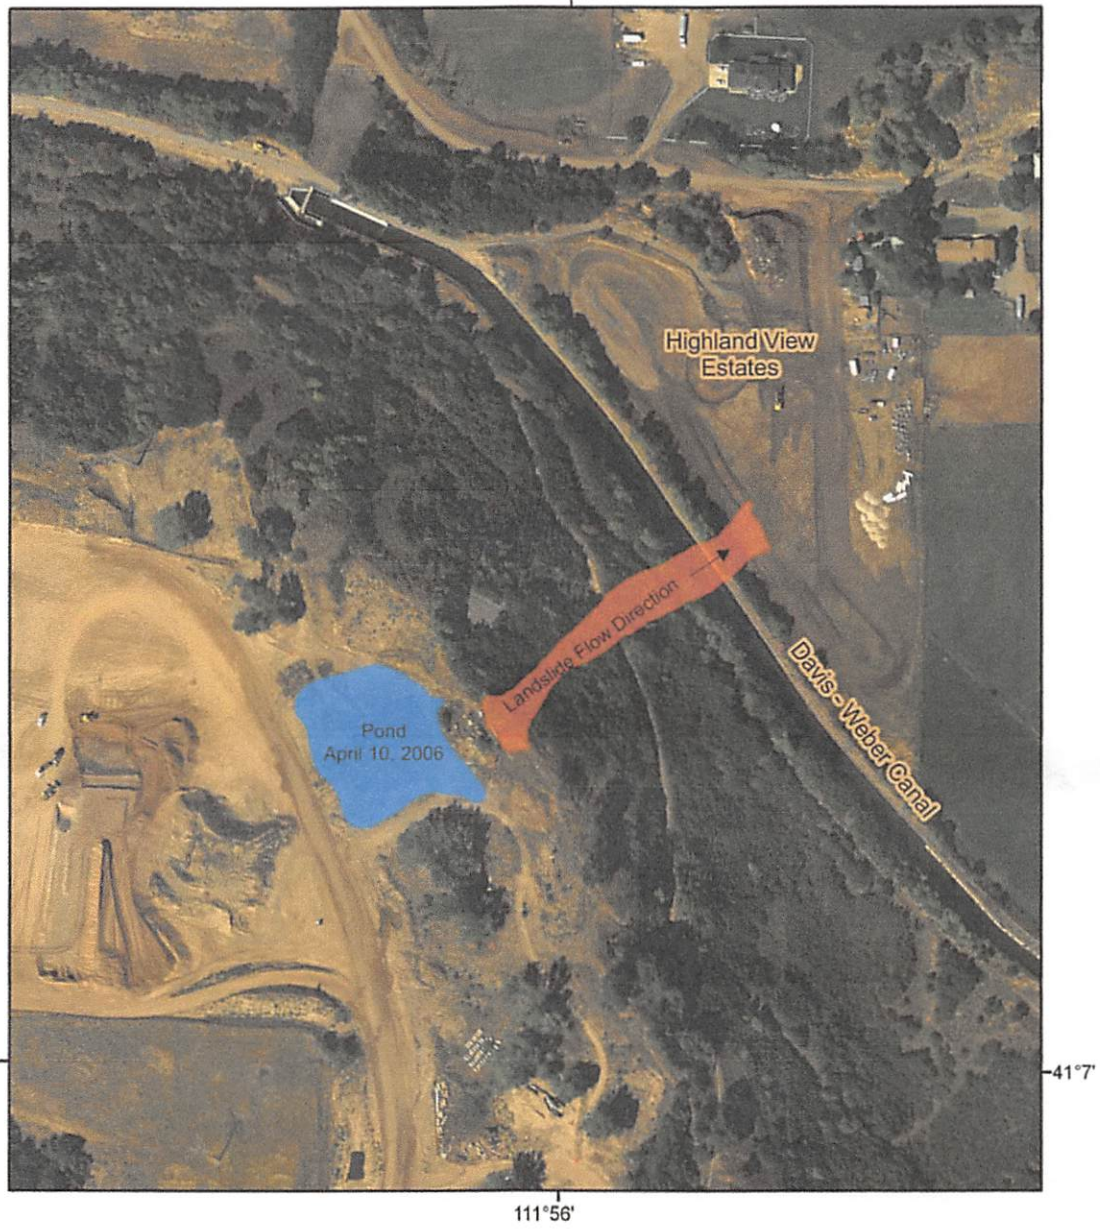
**Figure 2.** Image showing landslide flow direction, Highland View Estates subdivision, gravel pit pond, and the Davis-Weber Canal. The pond boundary is approximate and is based on oblique aerial photographs taken by Davis County Sheriff's Office personnel on the morning of April 10, 2006.

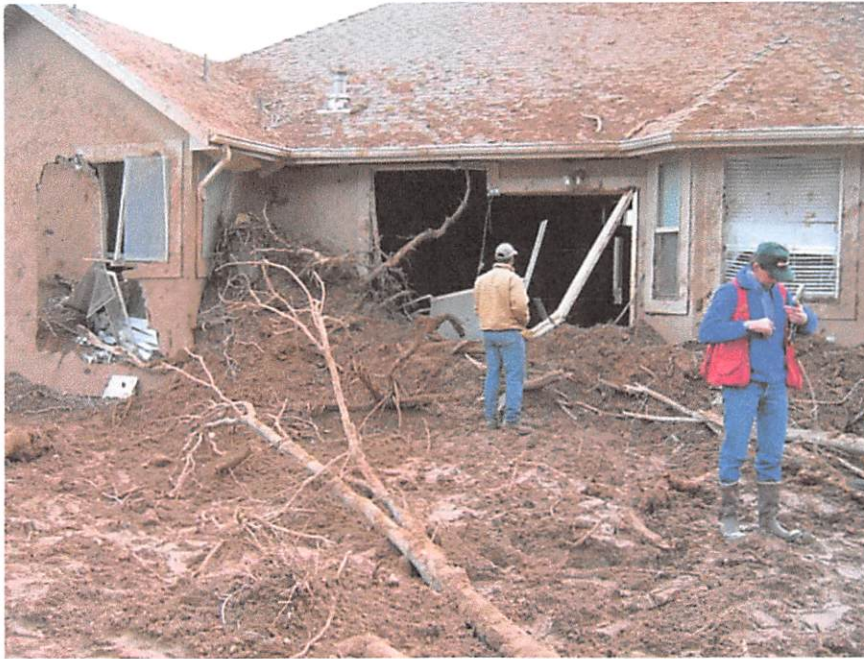
**Figure 3.** Landslide damage to the house at 1650 East 7687 South.

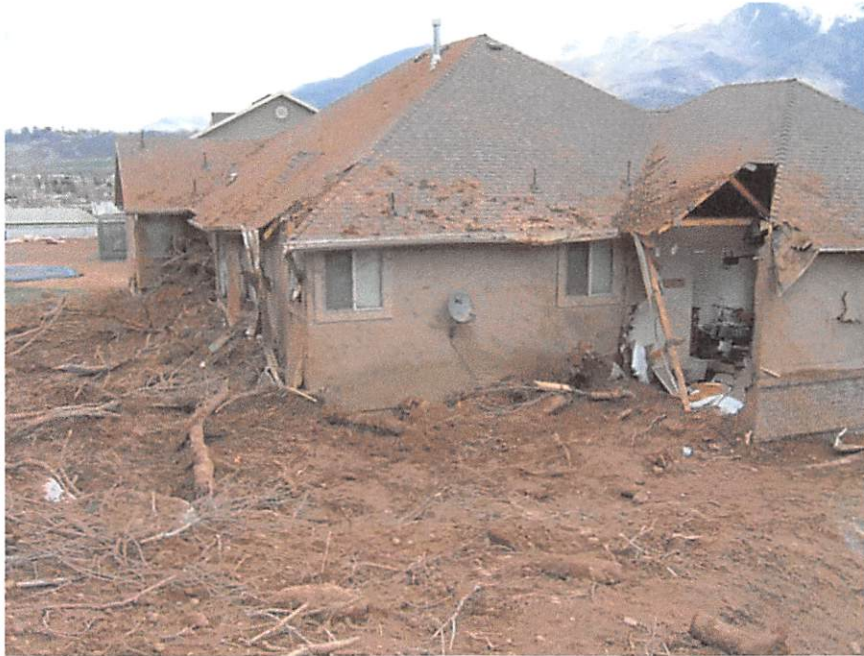
**Figure 4.** Damage to the house and garage at 1650 East 7687 South.

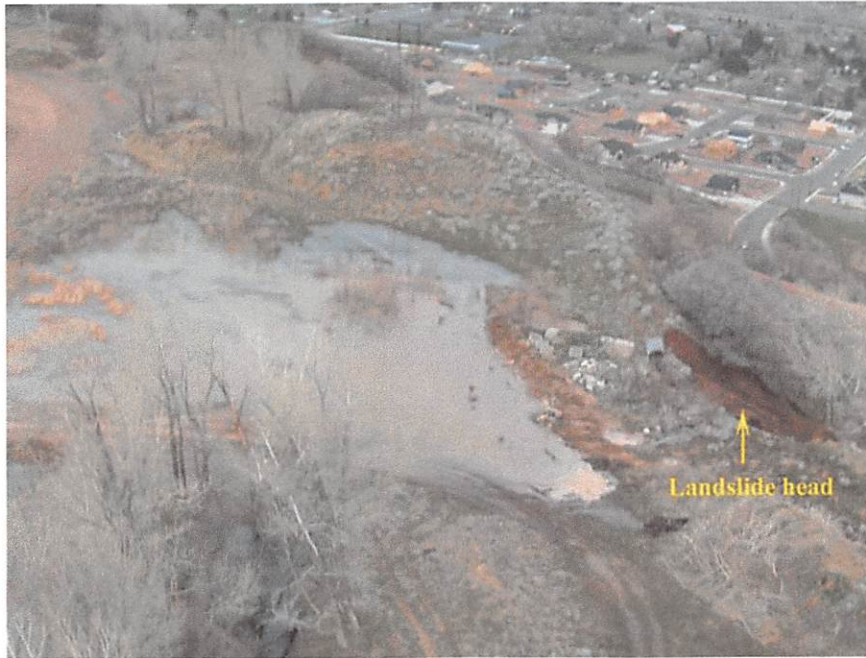
**Figure 5.** View looking northwest at the pond in the gravel pit and the landslide head (arrow). A berm was placed between the pond and the landslide to prevent water from flowing onto the landslide. Photo taken on the morning of April 10, 2005, by Davis County Sheriff's Office personnel.

the pond (figure 5) also indicate the presence of perennial shallow ground water since surface-water runoff alone would not sustain this vegetation. Cottonwood trees growing along the slope crest also indicate shallow ground water (figure 6). Following the landslide, a soil berm was placed between the pond and the landslide to prevent pond water from flowing onto the landslide head (figure 5).

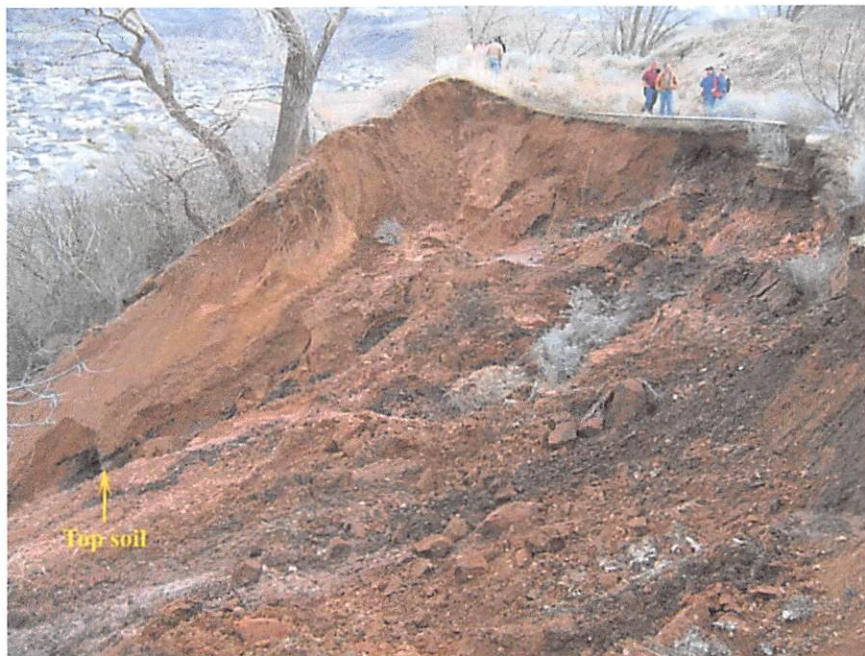
**Figure 6.** View to the southeast showing landslide main scarp and fill placed on the upper slope. Near the left edge of the photo, black top soil at the base of the scarp (arrow) underlying the brown fill is evident and indicates the original slope surface.

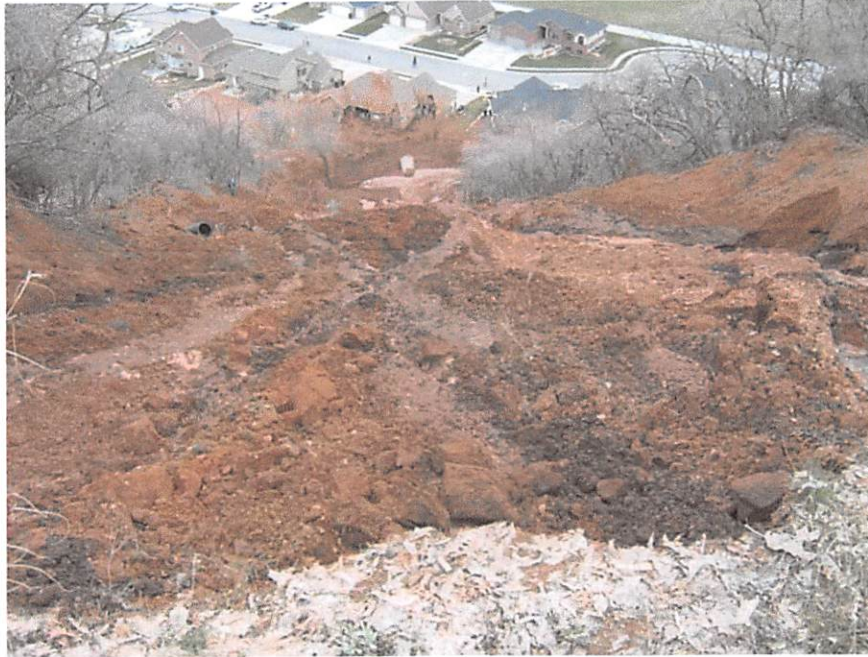
**Figure 7.** View looking down the landslide flow path at the damaged house at 1650 East 7687 South. The culvert in the lower slide path above the house was originally in the gravel pit. Subsequent water flow eroded the right side of the landslide.

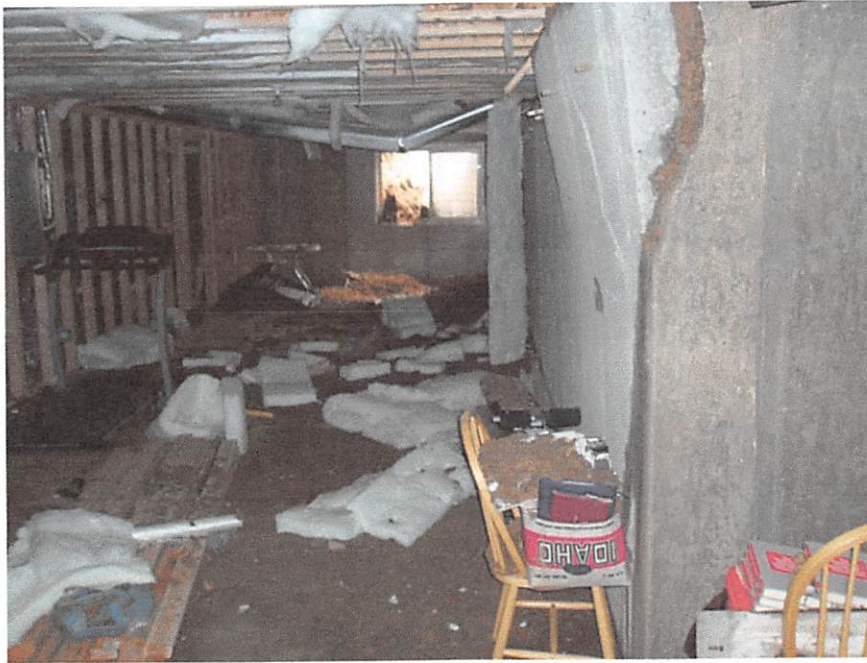
**Figure 8.** Basement at 1650 East 7687 South showing upper foundation wall (right side of photo) broken by landslide impact.

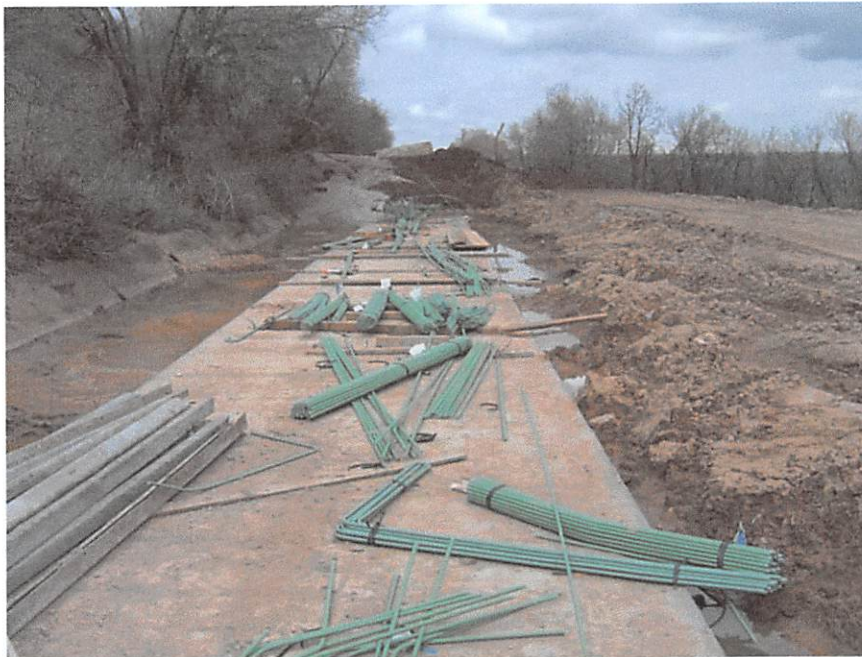
**Figure 9.** View looking northwest of Davis-Weber Canal showing landslide material deposited on the box culvert and canal access road. Following the landslide water and sediment flowed into the canal left of the box culvert.

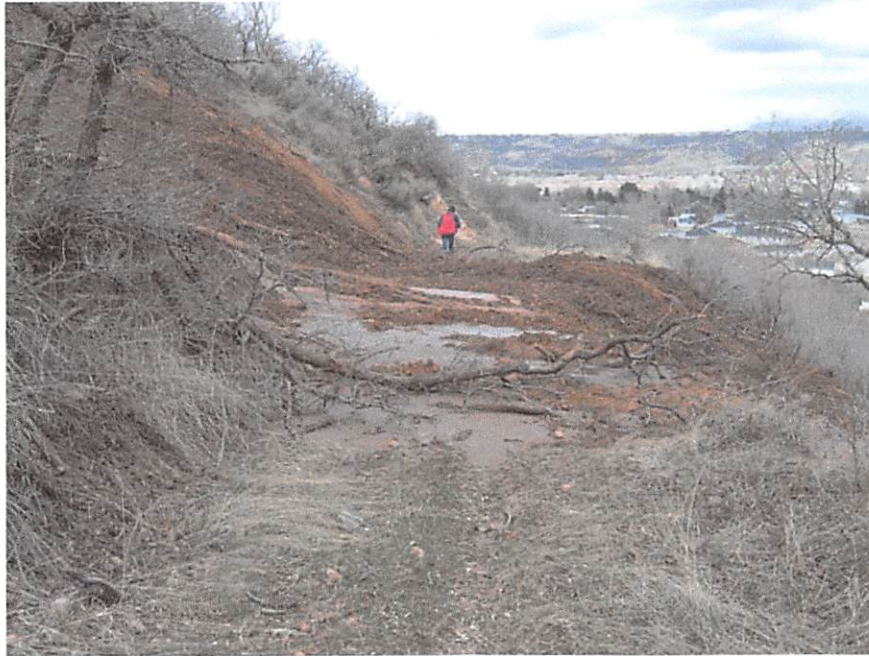
**Figure 10.** Landslide material deposited on a dirt road midslope above the Davis-Weber Canal.

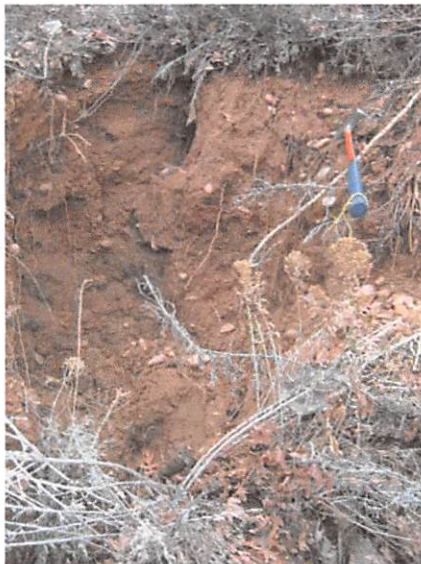
**Figure 11.** Piping holes in the upper slope near the landslide flanks. (a) Small piping hole near the landslide right flank. (b) Large piping hole adjacent to the landslide left flank.
