**Preliminary Slope Assessment Report**  
**Davis Landfill**  
**Davis County, Utah**

IGES Job No. 00169-034

May 5, 2005

# Preliminary Slope Stability Analysis

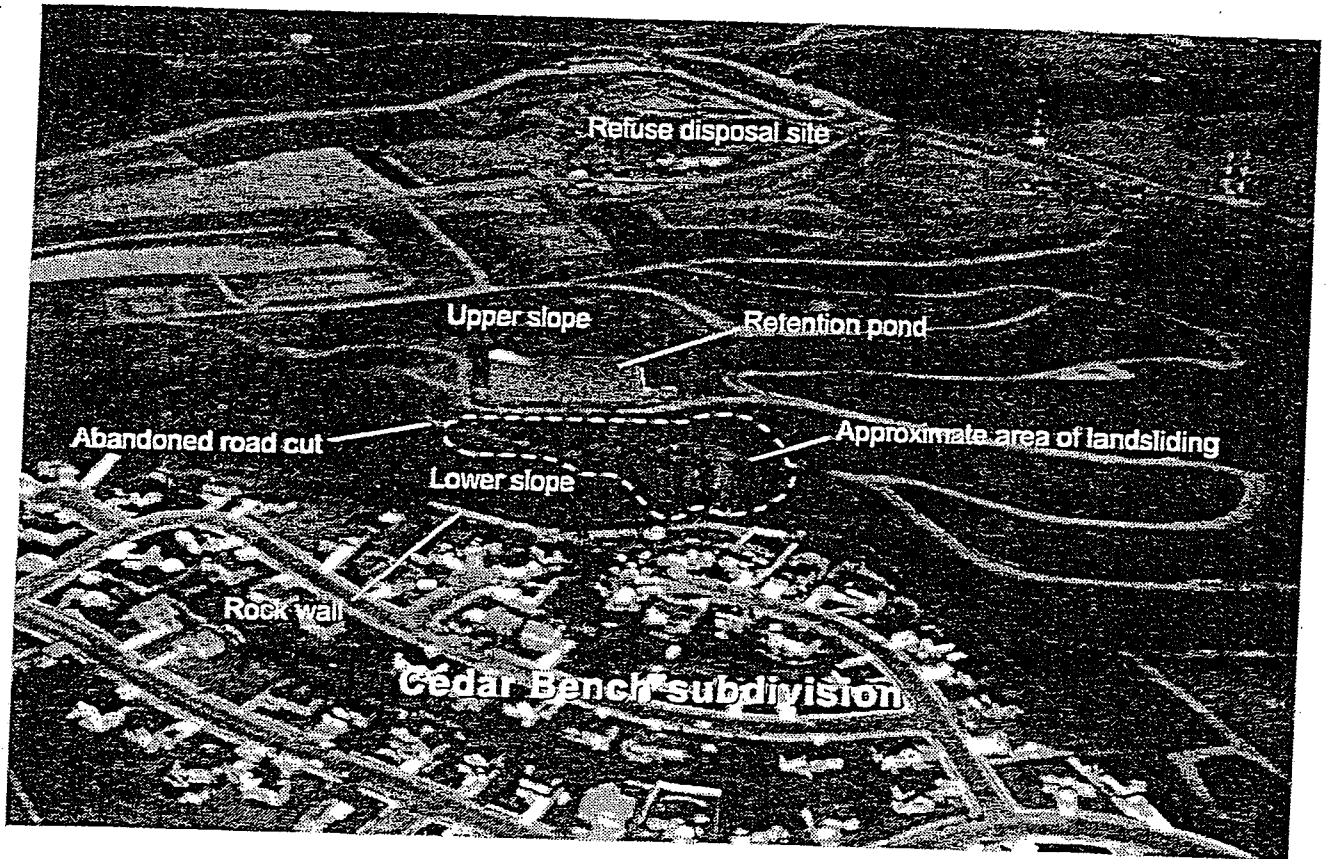
The 1998 landslide (attachment 3) is likely a composite slide consisting of ancient, deep-seated rotational slides or slumps (possibly reactivated) overlain by active, shallow translational earth slides and flows. Possible reactivation of the deep-seated ancient landslide deposits is suggested by subtle convex bulges in the lower part of the slope, and by a slight bend in the upper metal rail of the chain-link fence at the toe of the slope. However, without knowledge of pre-existing conditions, I cannot conclusively determine if deep-seated landslide movement occurred recently. I did not observe any ground cracks on the bench above the lower slope to indicate the presence of a deeper surface of rupture.

Attachment 2. Oblique aerial view looking south at the 1998 landslide near the Cedar Bench subdivision. Shallow earth slides are present on the lower slope below the retention pond and above the abandoned road cut. Earth slides and flows are present below the road cut to the toe of the slope.

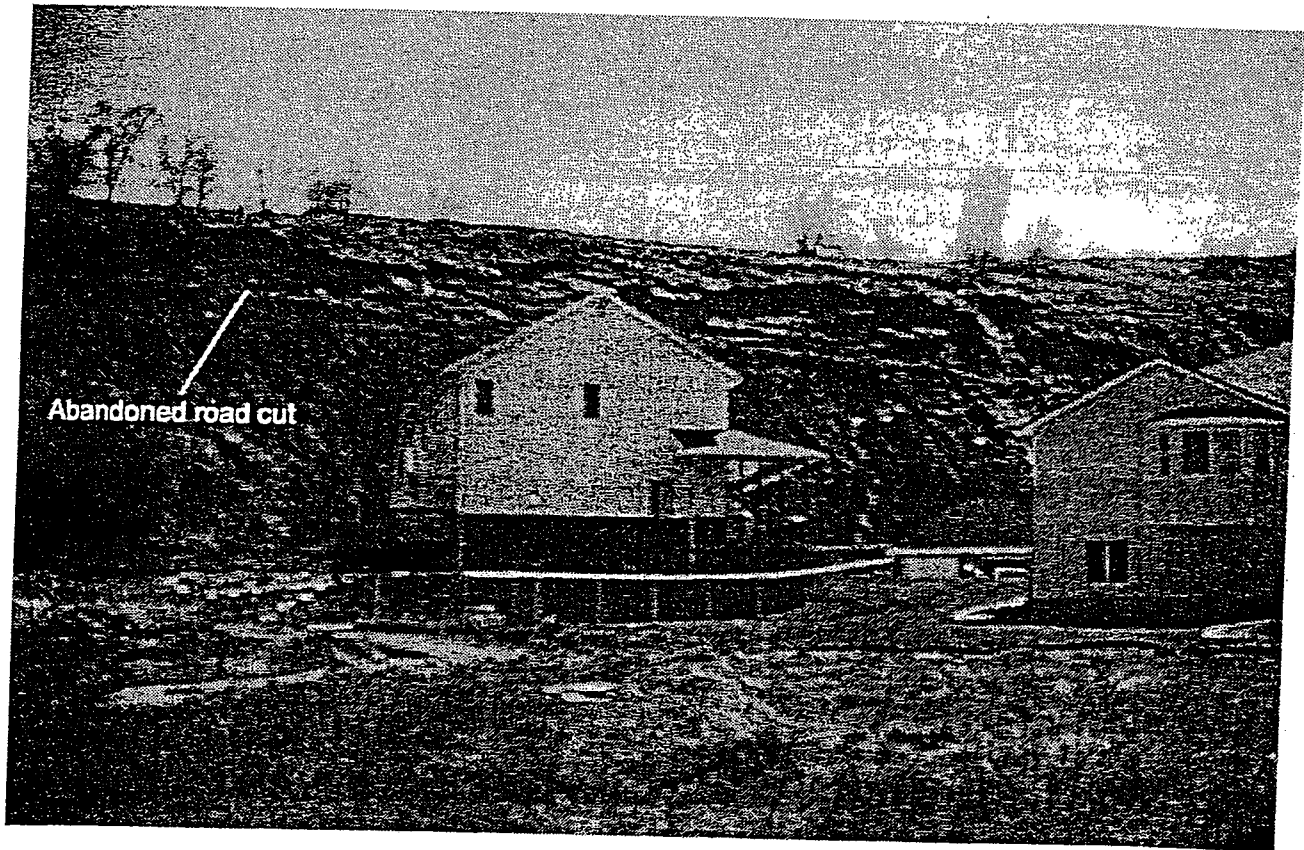
The complex of shallow slides is about 400 feet wide, and is mostly restricted to the area above the road cut in the lower slope. The maximum scarp height is about 8 feet at the head of slides along the road cut, but deformed ground and open ground cracks up to 4 inches wide extend upslope from the road cut for about 50 feet. The complex of shallow slides is thus about 2,000 square yards in area and, if the slip surface is about 8 feet deep on average, the estimated volume of the shallow slides is about 6,000 cubic yards. A small amount of slumping occurred along the lower edge of the road cut, and saturated silty sands flowed downslope from the road cut in two locations, but I estimate their volume to be small compared to the total volume upslope of the road cut. I did not observe any springs along the slope, but some soil in the road cut was damp. The only ponded water above the slope was in the unlined portion of the drainage ditch at the northeast corner of the complex of shallow slides. Delicate striations were preserved in two locations on slide planes in silty sand, indicating very recent movement prior to my April 24 visit. I did not notice any evidence of additional significant movement on April 29, but subtle movement may have occurred that I could not detect without quantitative measurements.

Attachment 3. South view of lower slope behind the Cedar Bench subdivision. Shallow earth slides are above and below the abandoned road cut.

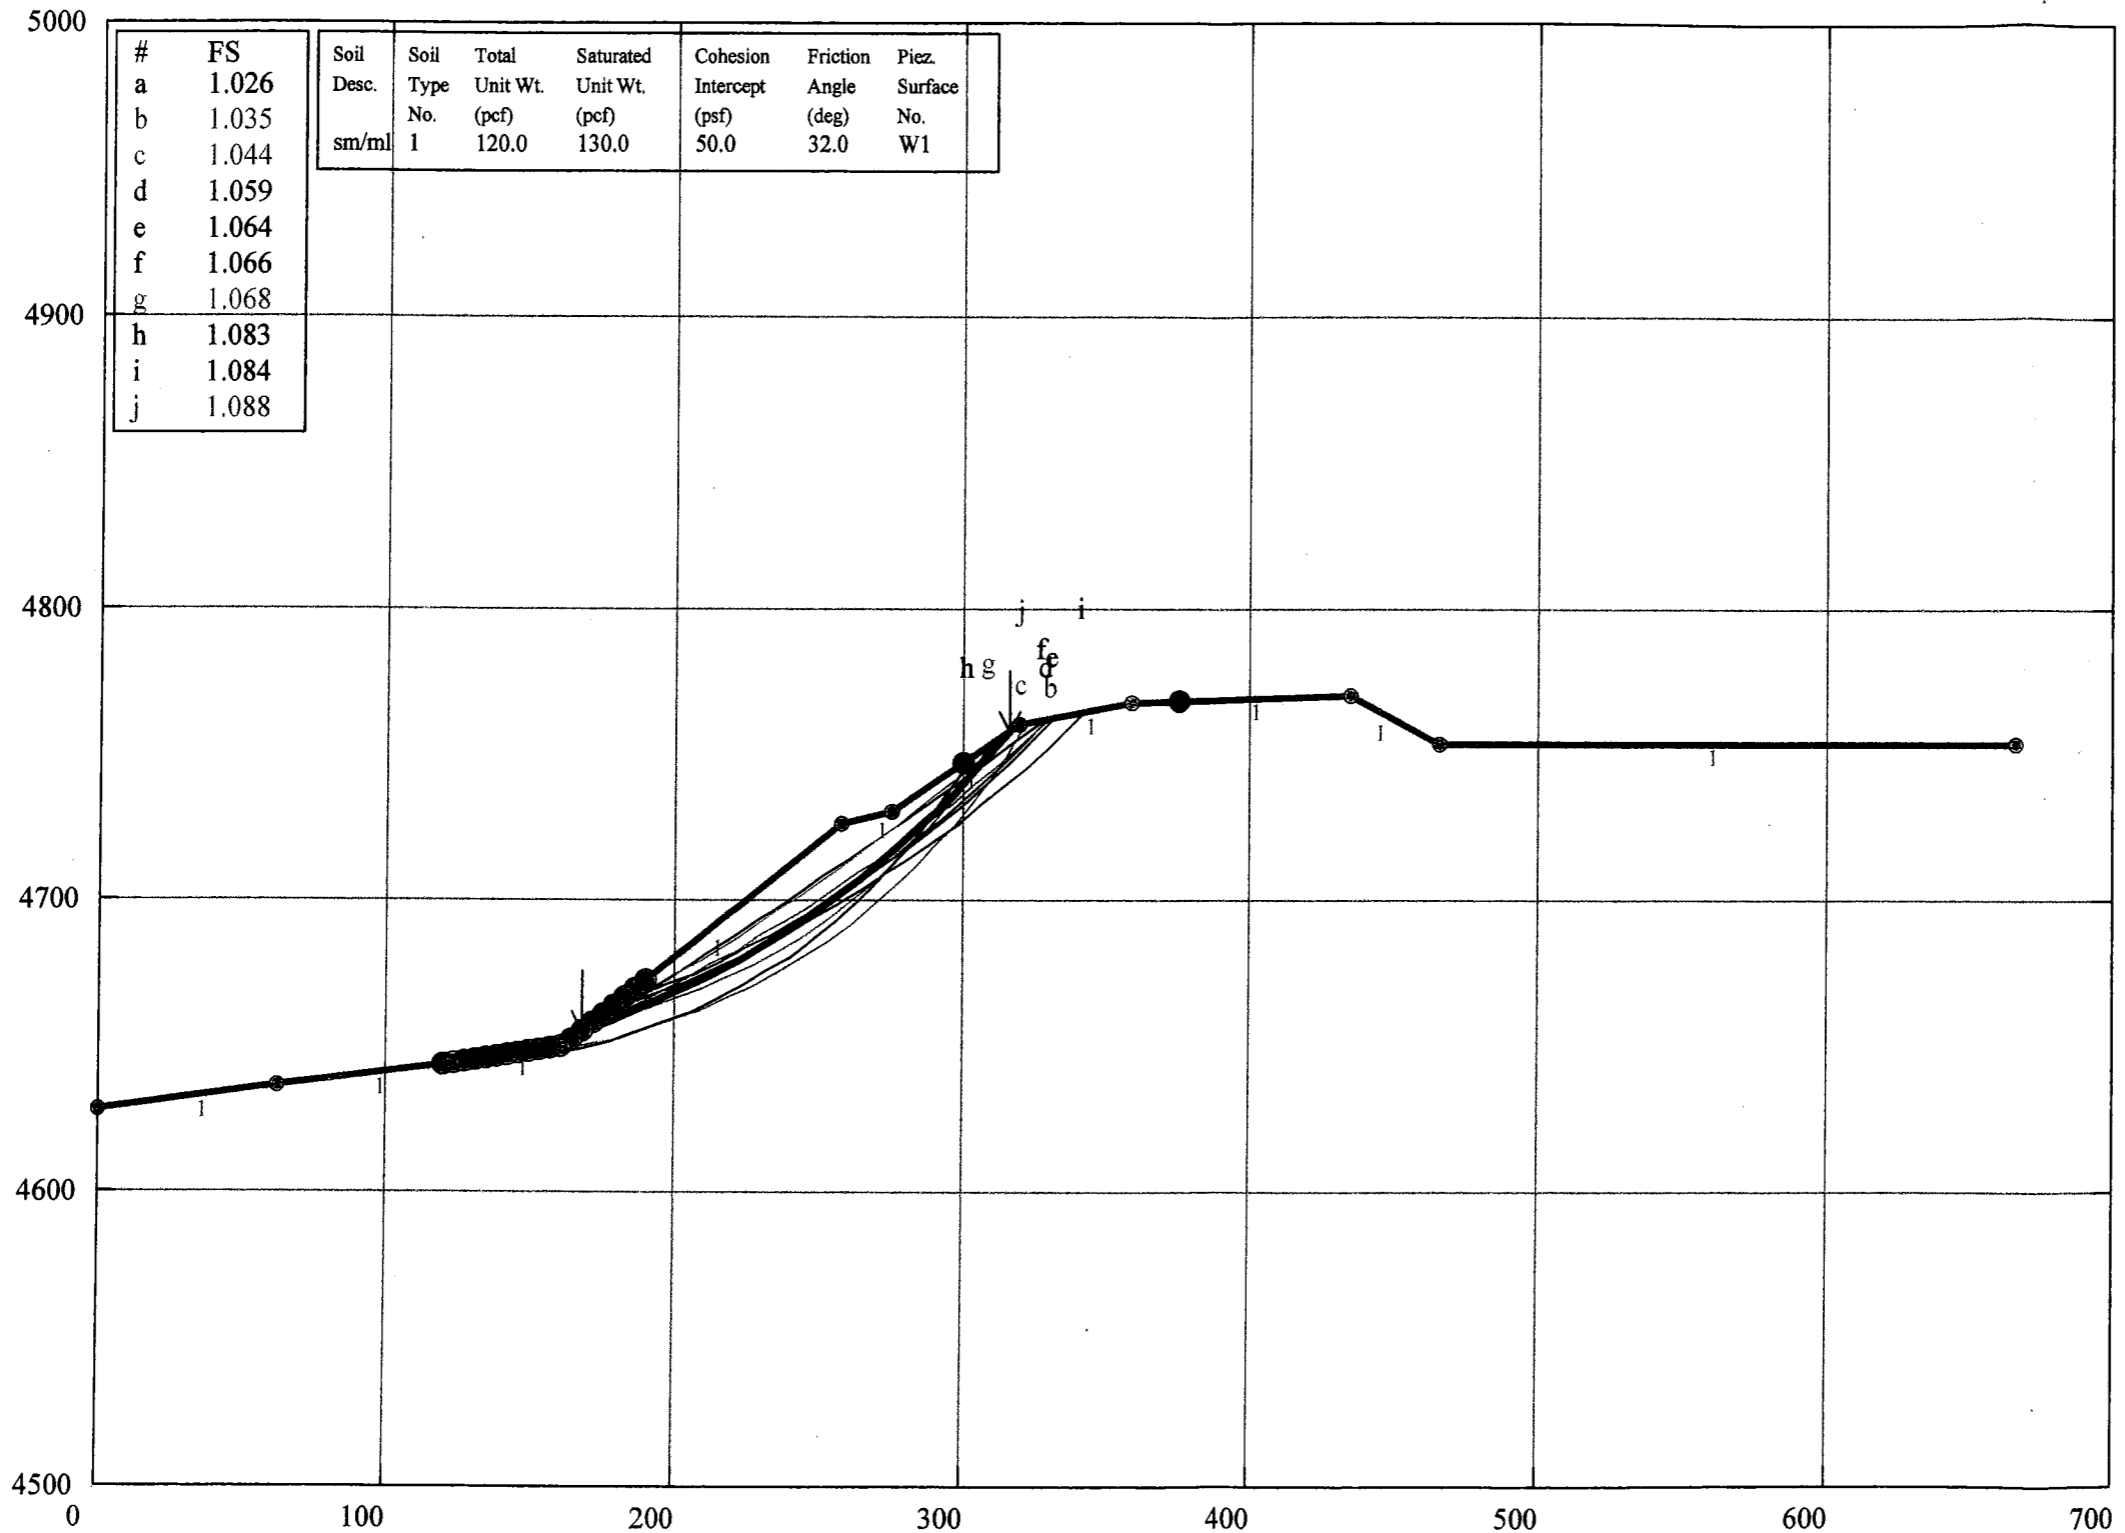
# Wasatch Integrated Section A Below Reservoir (STATIC - No GWT)

The slope stability sensitivity modeling suggests the static factor of safety ranges from a low of 0.51 to a high of 1.1. The results from the modeling are significantly less than a factor of safety of 1.5 which is the typical minimum industry standard recommended for the stability of natural

GSTABL7 v.2 FSmin=1.026

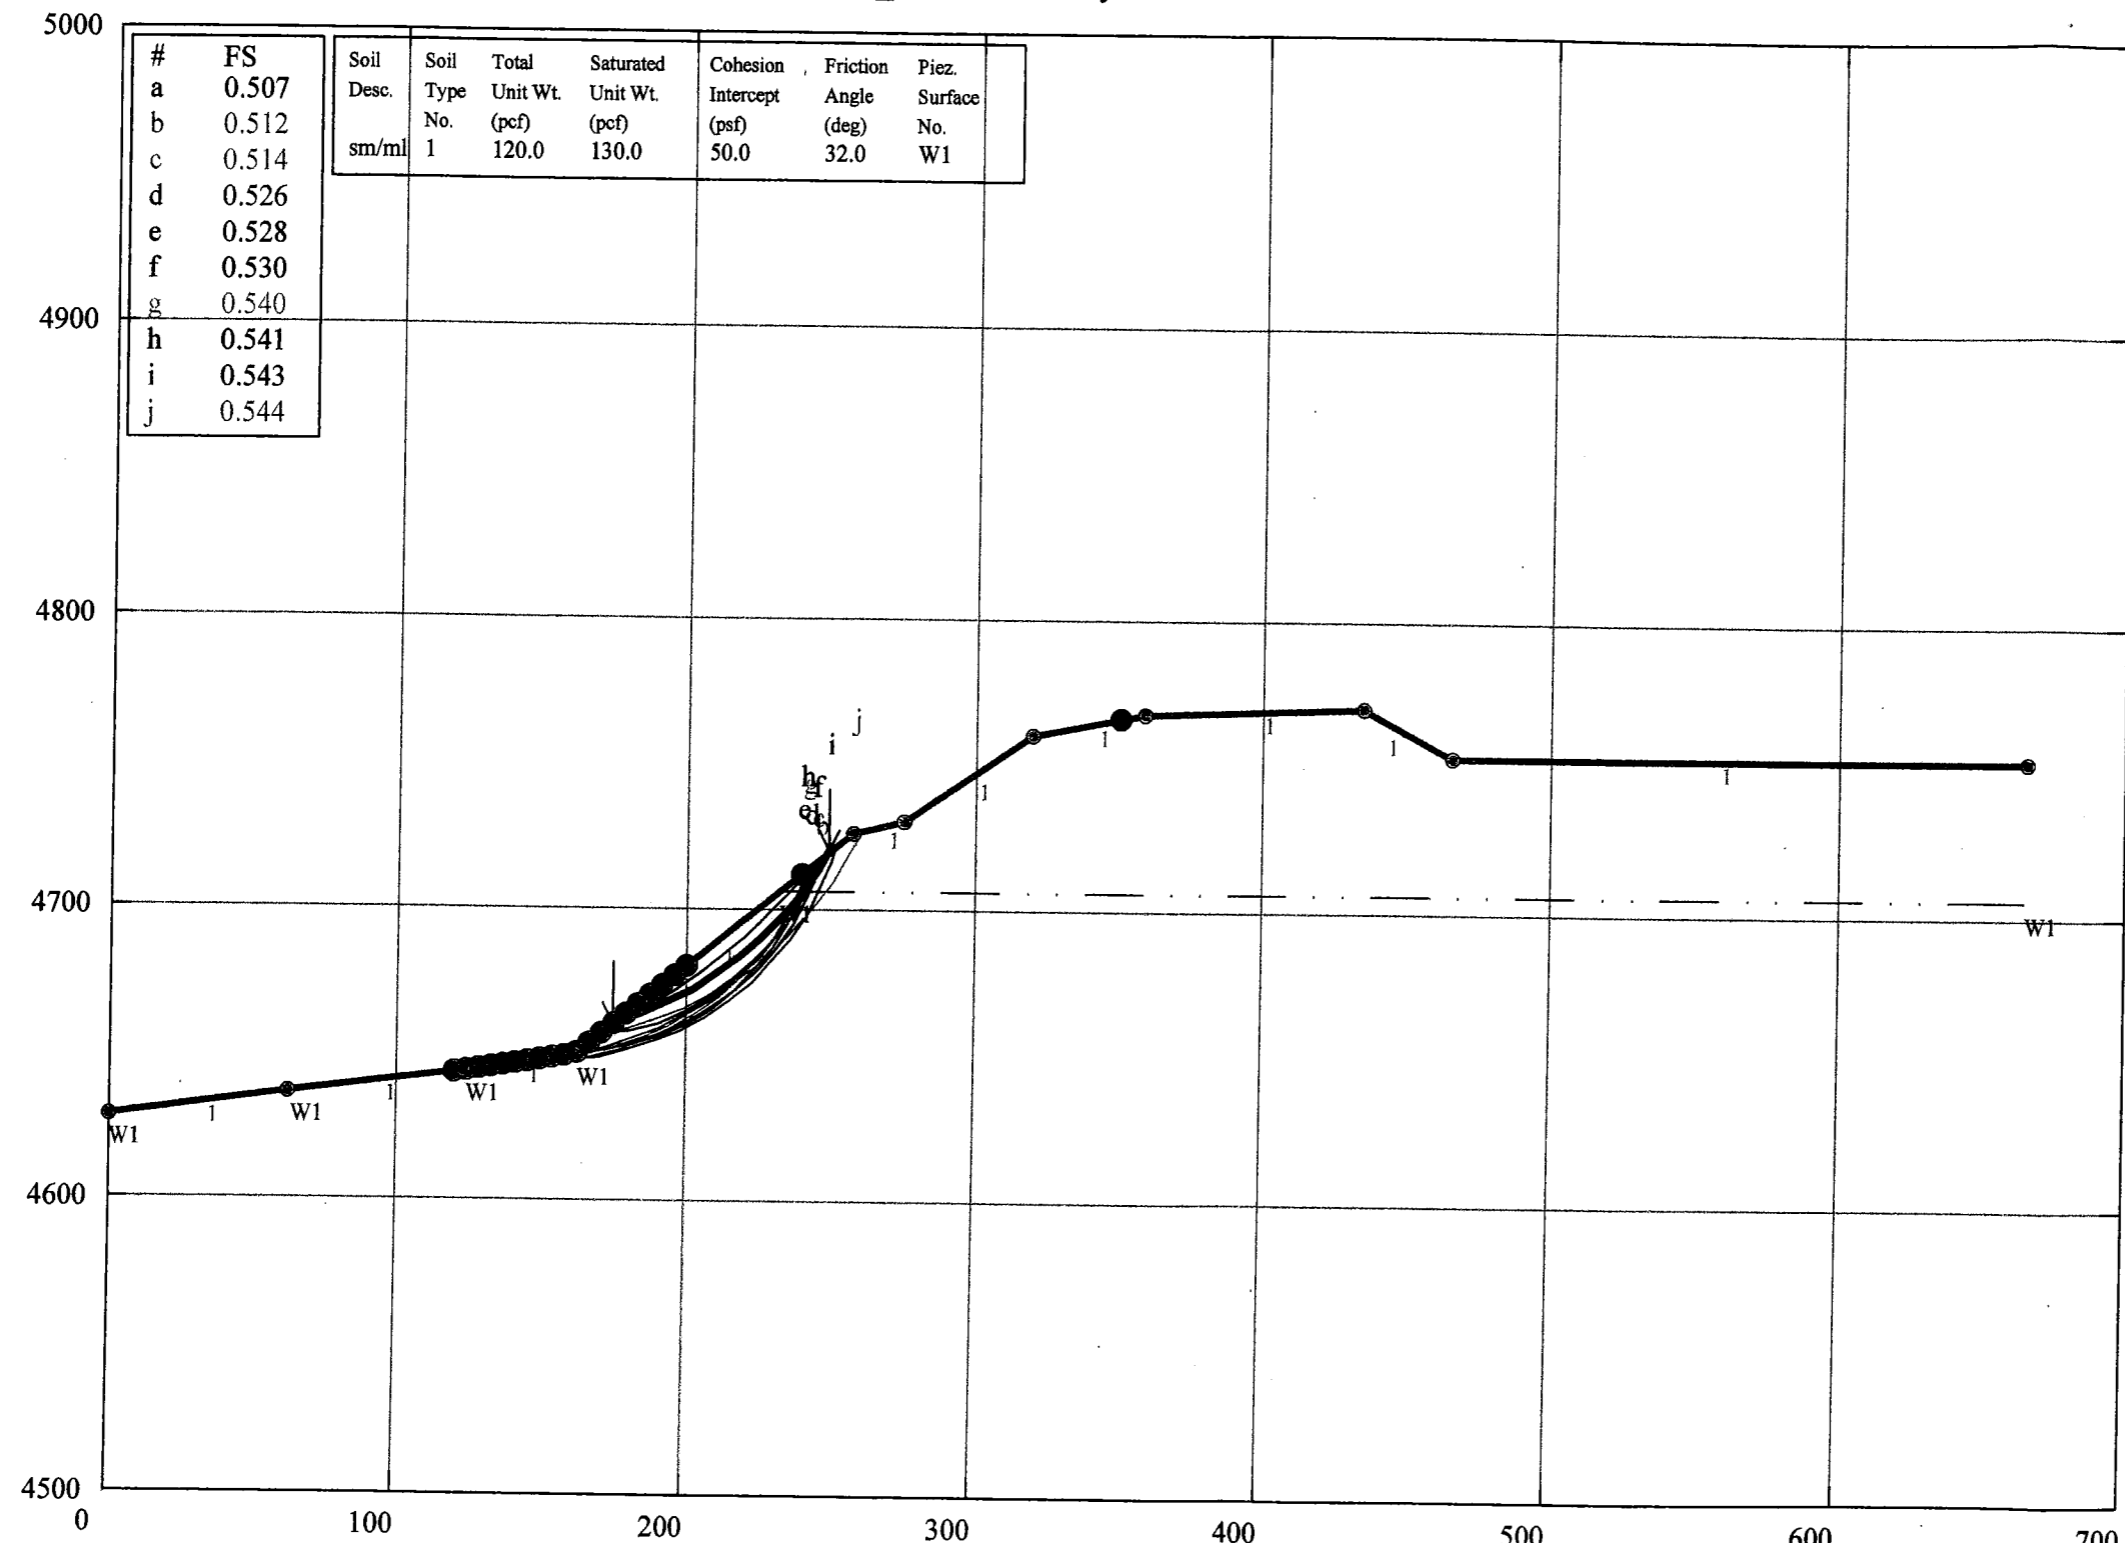
# Wasatch Integrated Section A Below Reservoir (STATIC - With GWT)

slopes. Based on the stability modeling combined with the survey data and field observations, it is our professional judgment the overall existing factor of safety of the slope is significantly less than 1.5, and therefore the slope is not stable under current static conditions. Figures D3 and D4 show the failure planes and factors of safety associated with static conditions.

GSTABL7 v.2 FSmin=0.507  
Safety Factors Are Calculated By The Modified Bishop Method

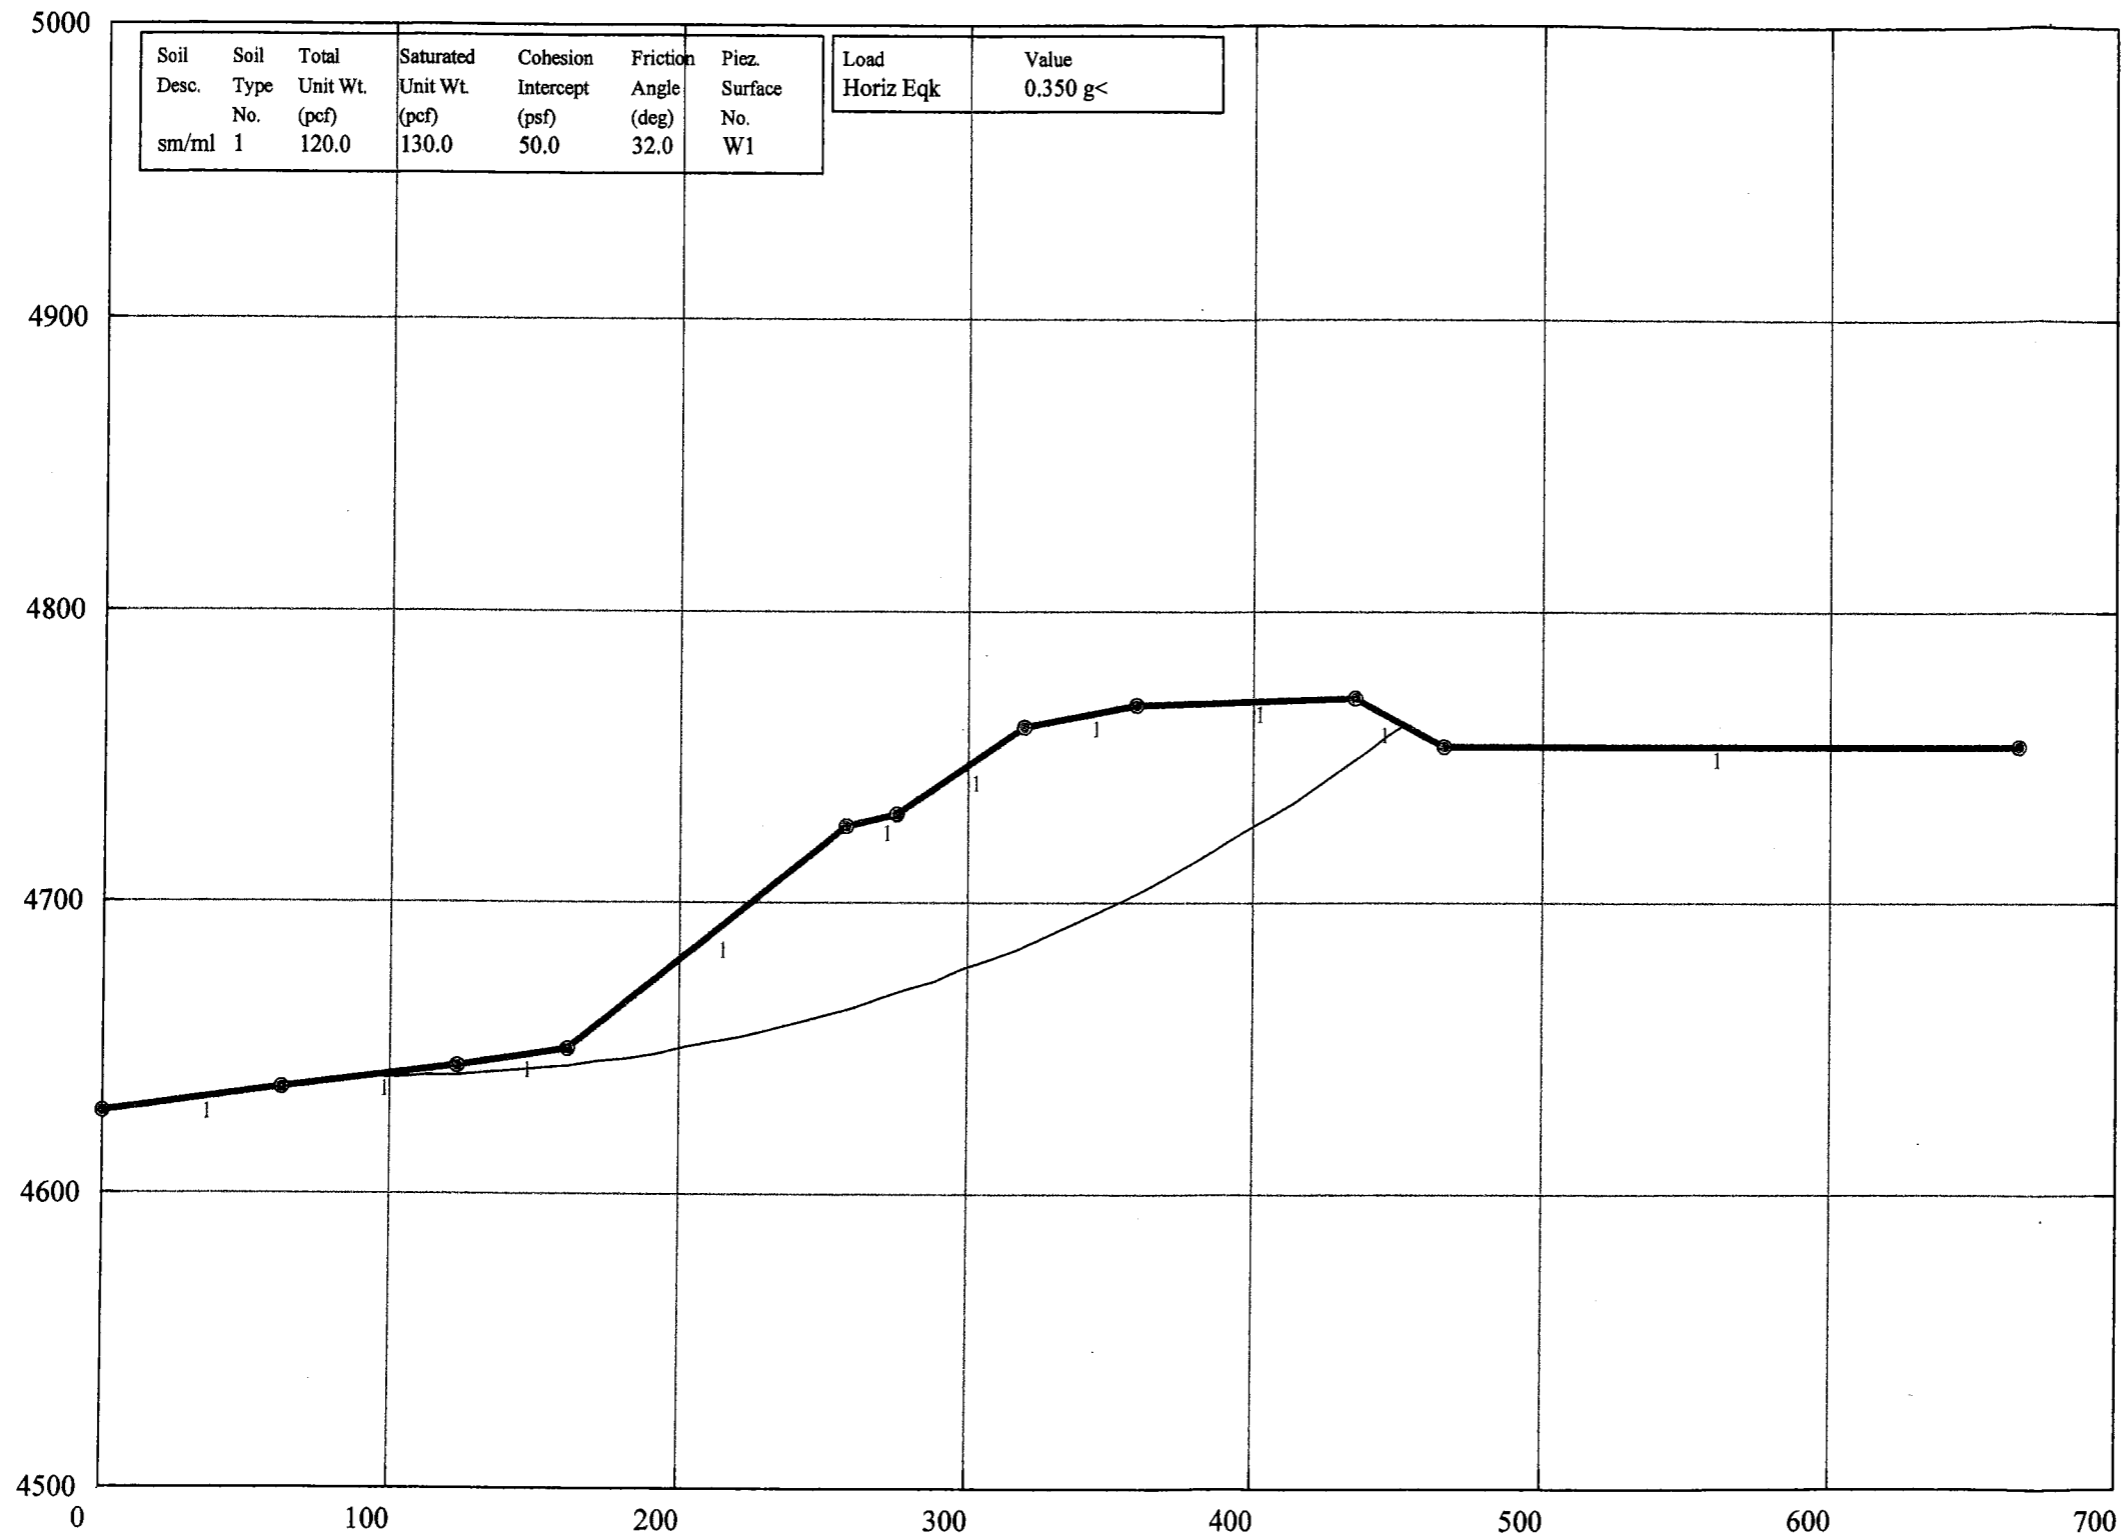
# Wasatch Integrated Section A Res. Below Reservoir (SEISMIC - No GWT) MCE

The results from this simplified analysis resulted in factors of safety ranging from 0.59 to 0.78; and there is a potential for excessive deformation of the reservoir under MCE ground motions. The magnitude of deformation is anticipated to be much greater than 3 feet and may be up to 11 feet, however based on the limited data and simplifying assumptions used in the modeling this value may be significantly different and would require a more detailed site specific study including detailed geologic and subsurface geotechnical information to provide a more defined estimate of the anticipated deformation of the reservoir under MCE ground motions. Based on this information it is our judgment that the slope is not stable under seismic conditions and there is high risk associated with the potential breach of the reservoir located on the crest of the slope. Figures D5 – D8 show the failure planes and factors of safety associated with seismic conditions.

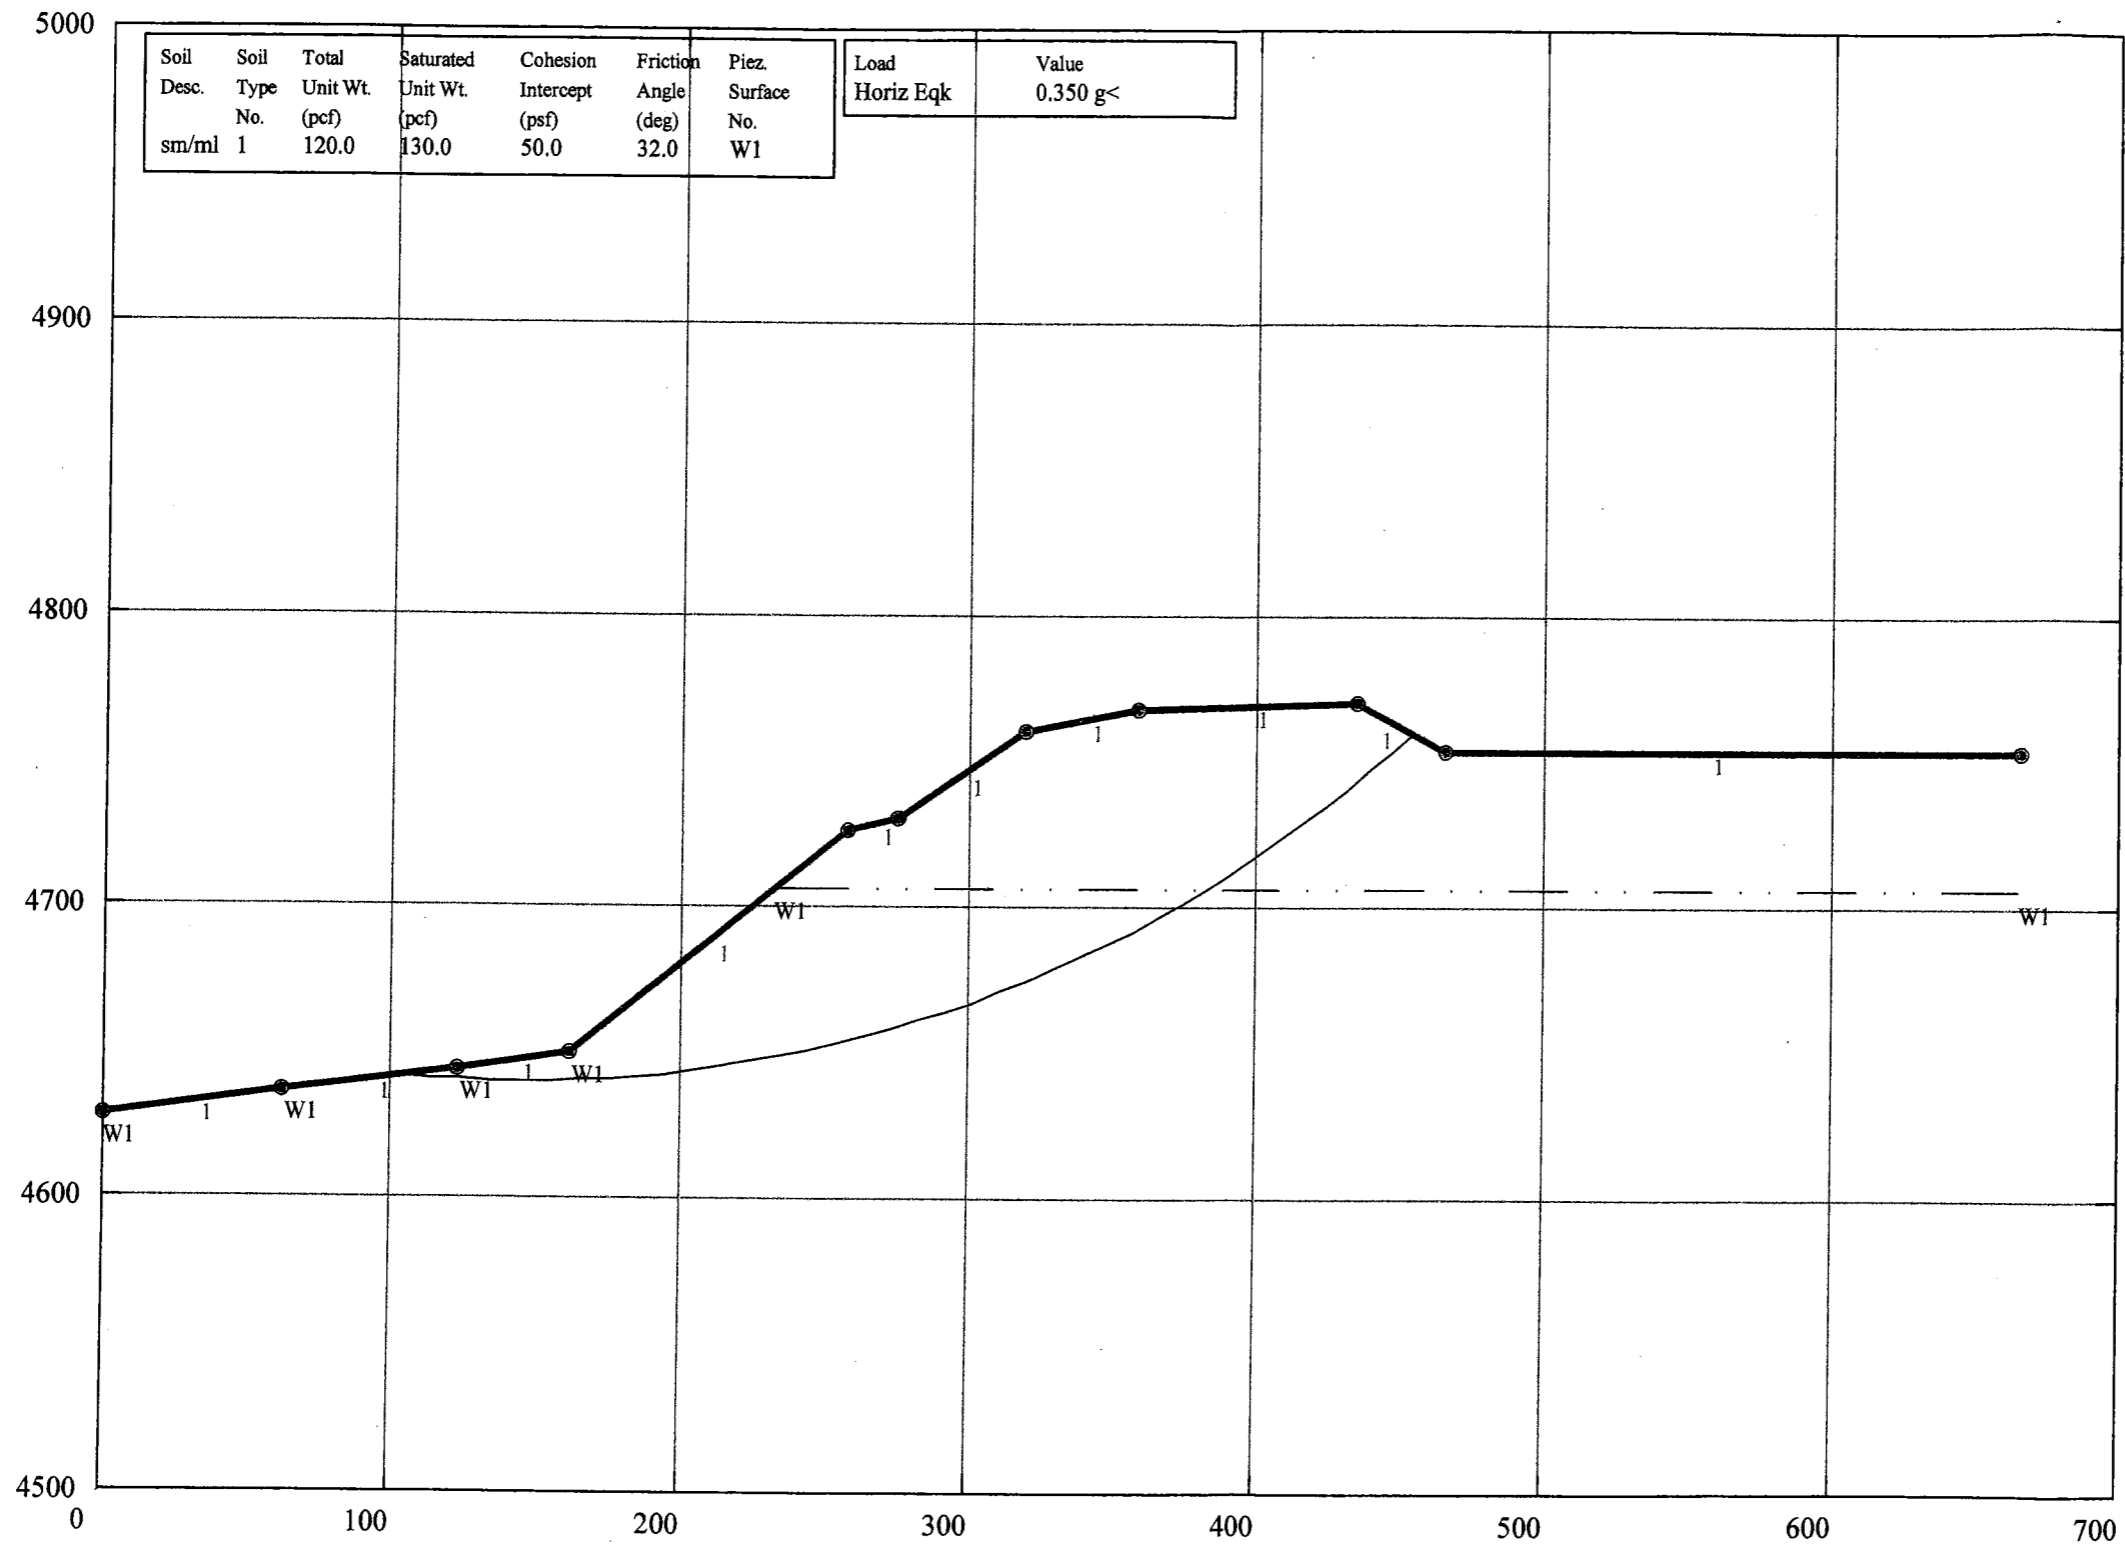
# Wasatch Integrated Section A Res. Below Reservoir (SEISMIC - With GWT) MCE

GSTABL7 v.2 FSmin=0.589  
Factor Of Safety Is Calculated By The Modified Bishop Method

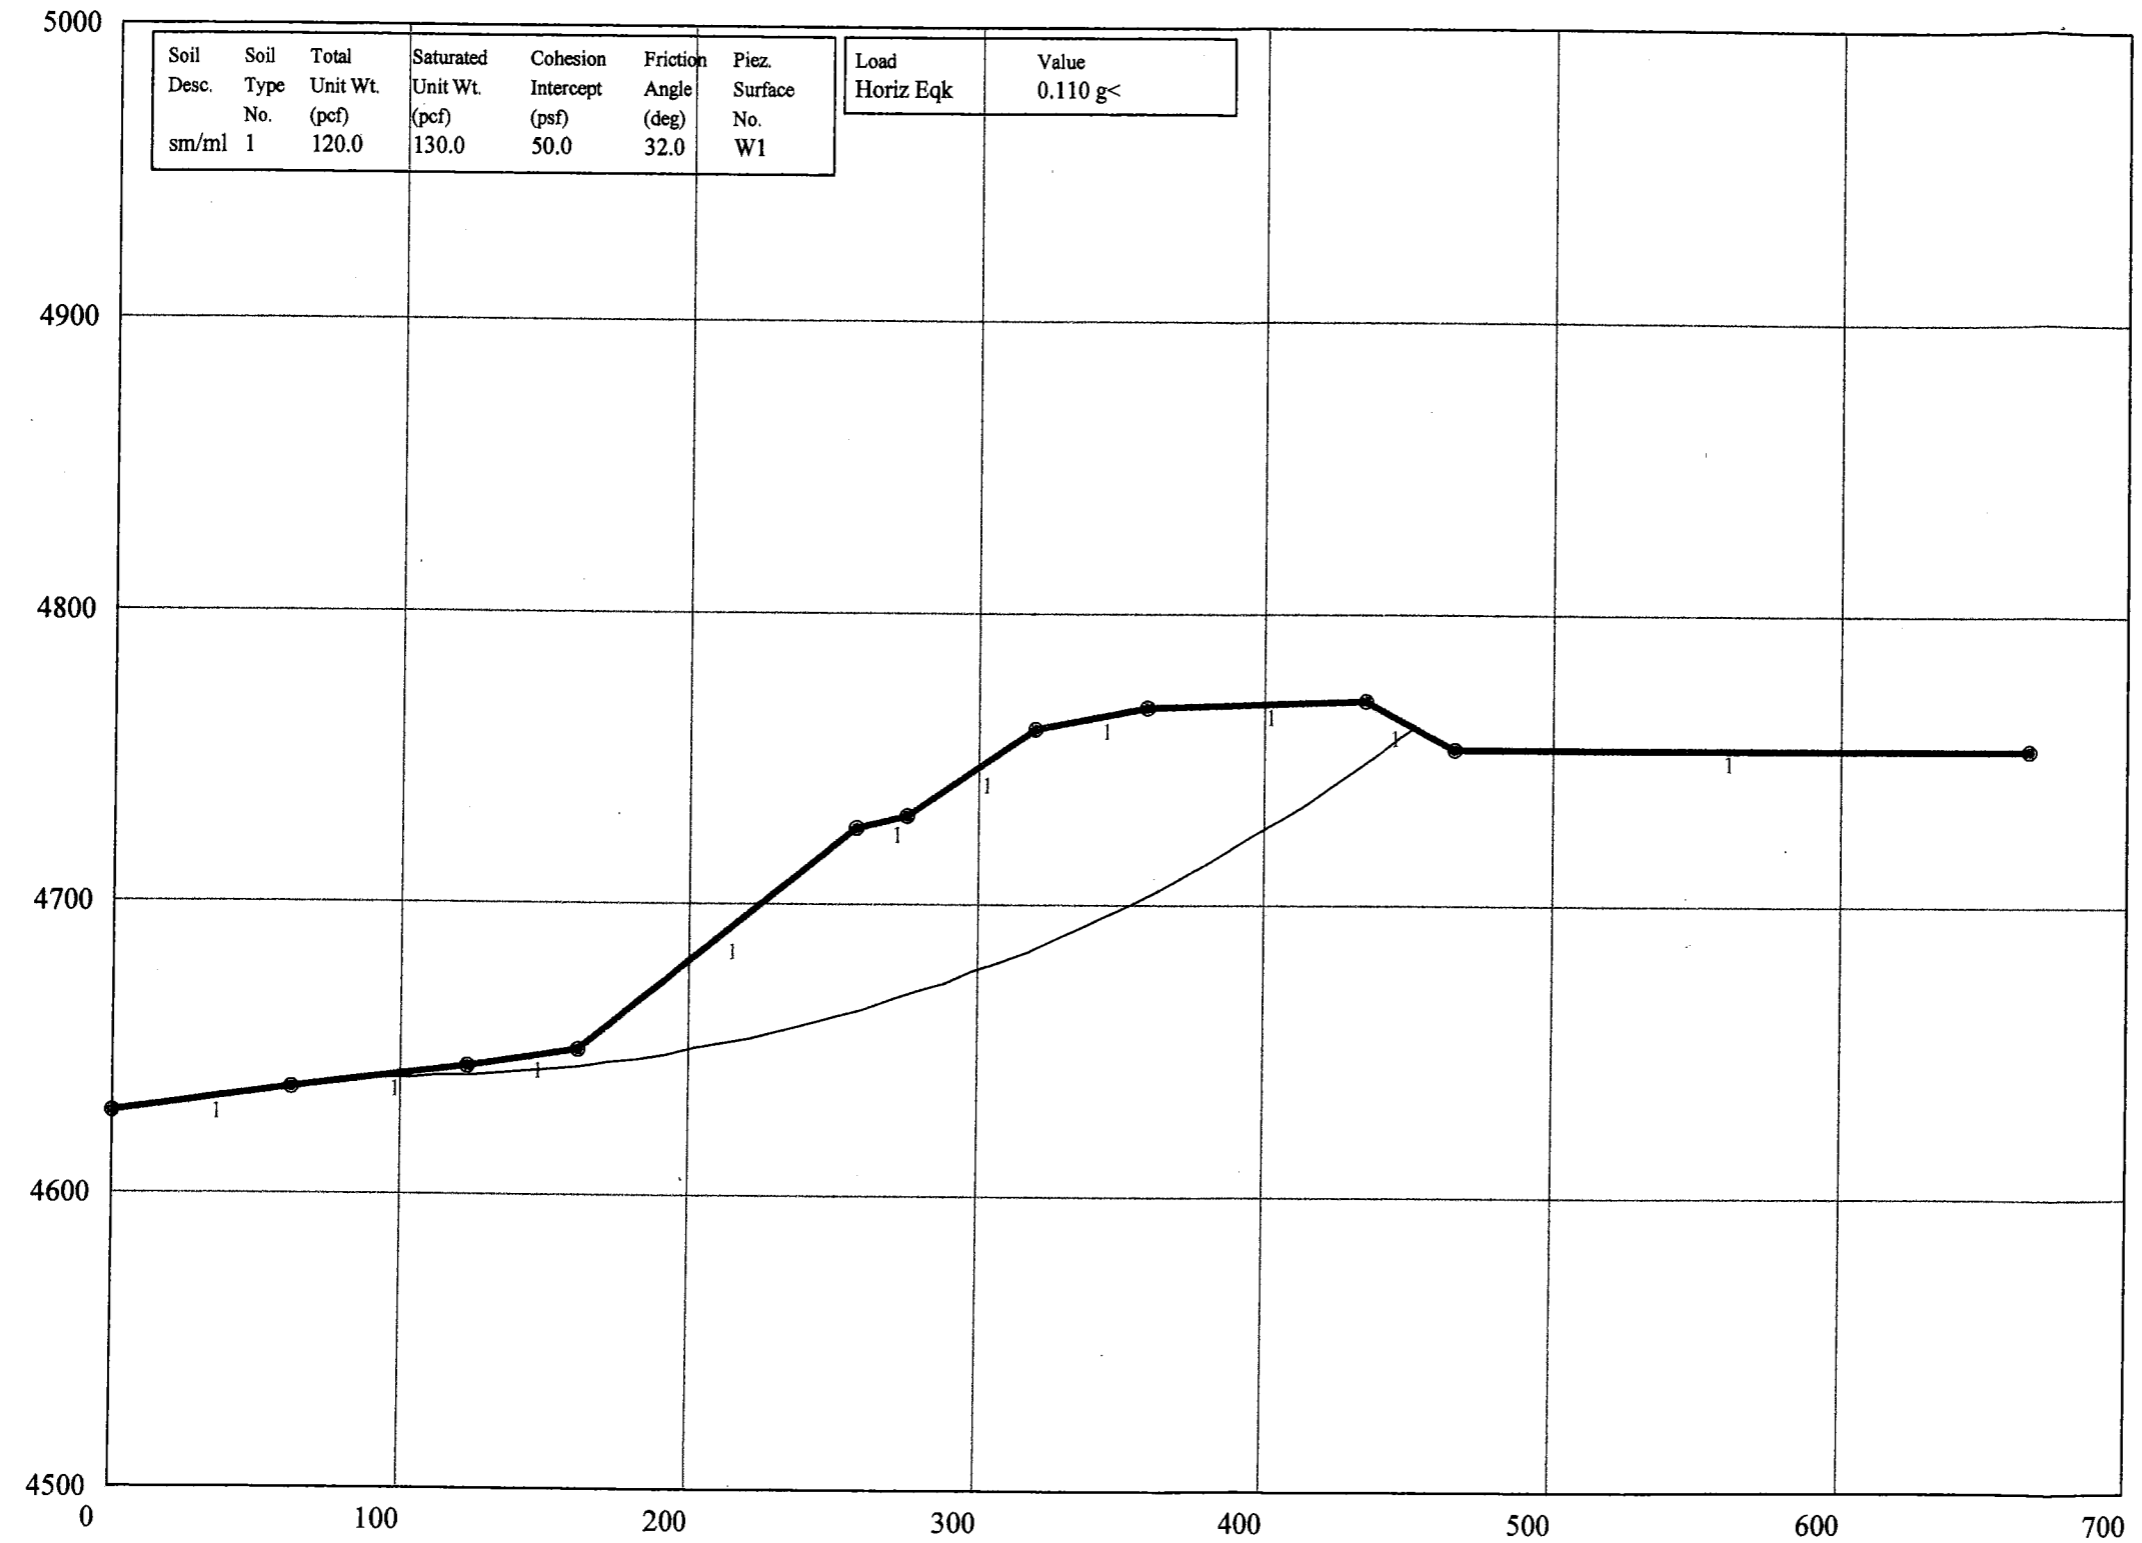
Wasatch Integrated Section A Res. Below Reservoir (SEISMIC - No GWT) OBE

Using this guideline the minimum factor of safety under the OBE ground motion should be a minimum of 1.0. The slope stability sensitivity modeling suggests the factor of safety ranges from a low of 0.97 to a high of 1.26. These results indicate the slope may not meet the State of Utah Statutes minimum requirements for the OBE ground motion if the statutes are applicable.

GSTABL7 v.2 FSmin=1.261
