**Preliminary Slope Assessment Report**  
**Davis Landfill**  
**Davis County, Utah**

IGES Job No. 00169-034

May 5, 2005

# Preliminary Slope Stability Analysis

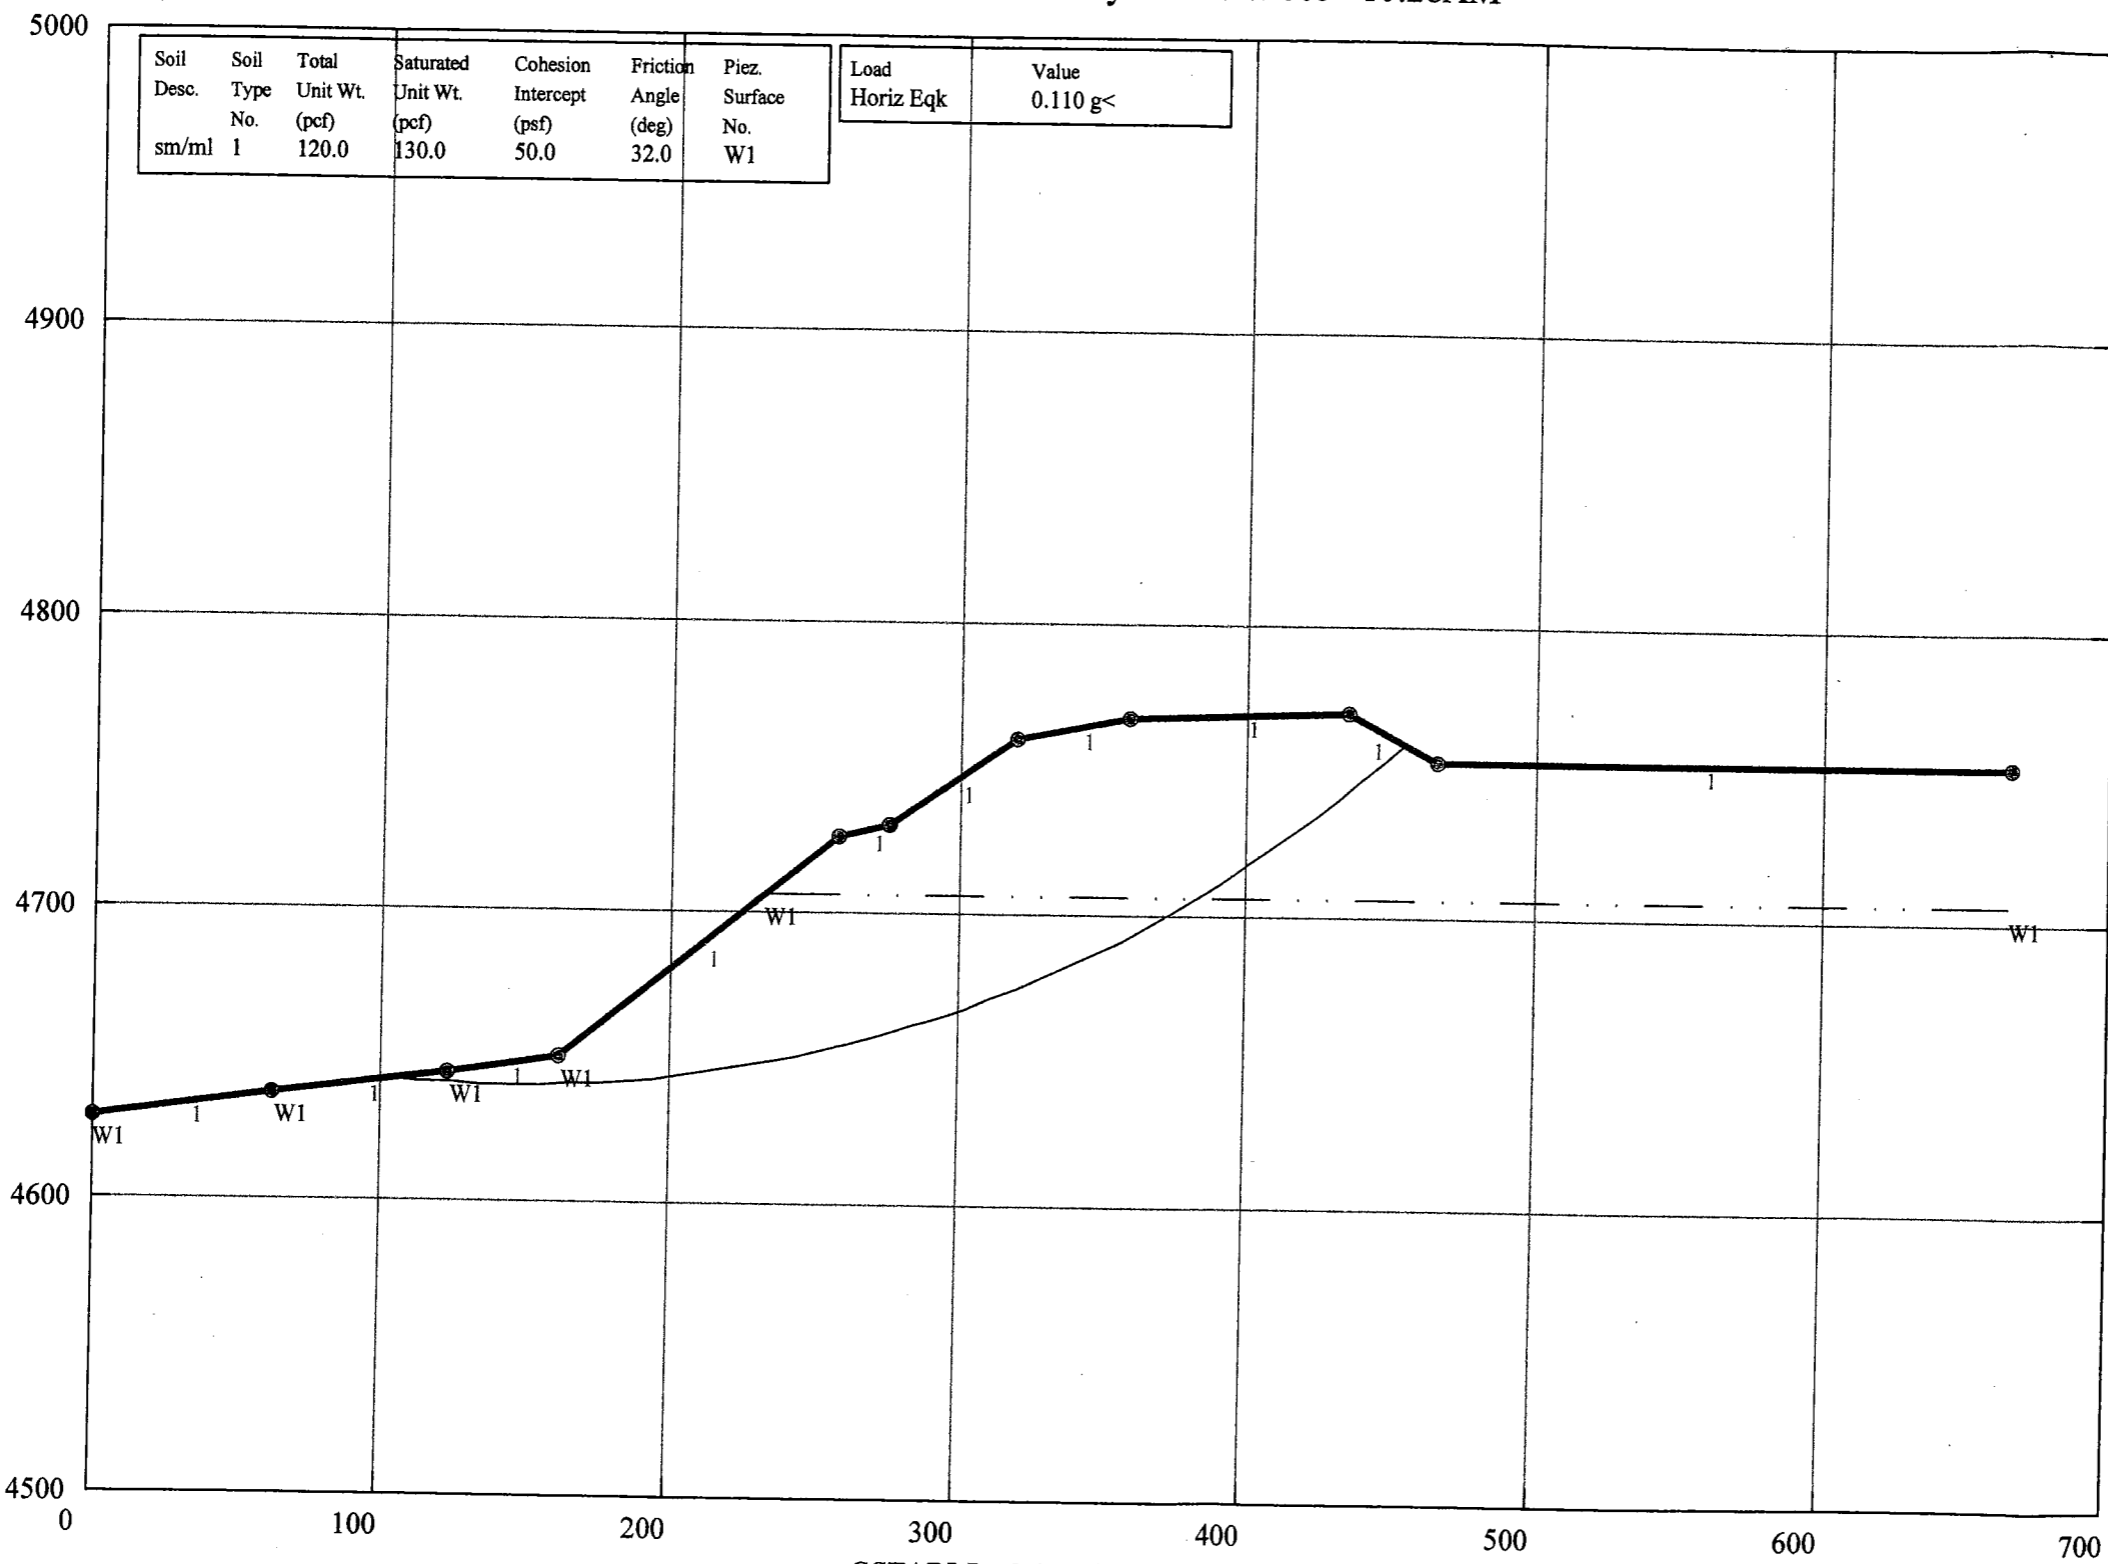
Wasatch Integrated Section A Res. Below Reservoir (SEISMIC - With GWT) OBE

Using this guideline the minimum factor of safety under the OBE ground motion should be a minimum of 1.0. The slope stability sensitivity modeling suggests the factor of safety ranges from a low of 0.97 to a high of 1.26. These results indicate the slope may not meet the State of Utah Statutes minimum requirements for the OBE ground motion if the statutes are applicable.

GSTABL7 v.2 FSmin=0.973  
Factor Of Safety Is Calculated By The Modified Bishop Method
